Background Information:

The photo below shows some sign of bubbles in the finished graphics. The substrate material is polycarbonate which was supplied from a polycarbonate supplier.

3M Commercial Solutions Division

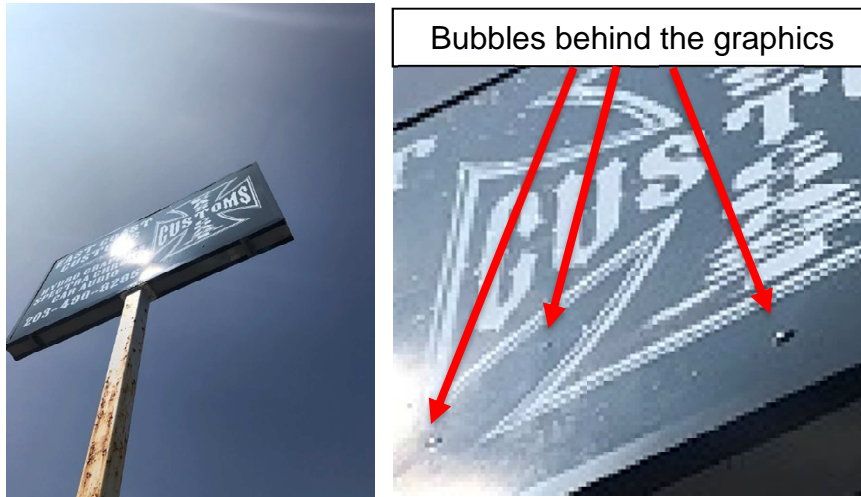
The root cause of the bubbling is the outgassing of moisture from the polycarbonate panels and not from the film lifting or poor installation.

To prevent the bubbles in the future, the polycarbonate panel must be dried prior to installation and procedures followed as outlined in the article from Tuffak® (see Appendix).

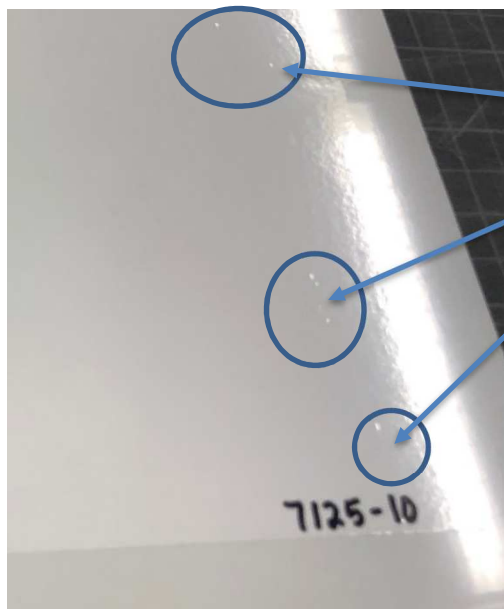
Regarding the theory that air may have been trapped during the installation process. The 3M™ Wrap Film 1080-G10 and 3M™ Wrap Film 1080-G12 have a Comply™ feature and no trapped air was present from installation. While there was some evidence of trapped air during the installation of some films such as 7125-10, the films that had trapped air from installation would be the products without an air egress channel like Comply™. These products are the 3M™ Scotchlite™ Reflective Graphic Film IJ5100R, 3M™ Scotchcal™ Electrocut™ Graphic Film 7125-10 and 3M™ Scotchcal™ Electrocut™ Graphic Film 7725-12. Typically, the trapped air would be very small, random bubbles that would not show up in the overall sign. Therefore, the large bubbles are not due to the installation process.

Examples of trapped air during installation.
