Wingman's Guide

Troubleshooting Top 10 Issues

Troubleshooting Top 10 Issue

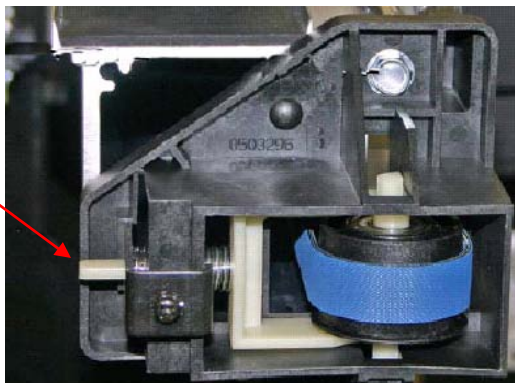
6. Remove the service-side cover and inspect the idler assembly, when the carriage drive belt is properly tensioned, the white tab shown in the picture below will extend past the edge of the idler by a couple of millimeters. Re-tension the belt if needed and retest.

The end of the white tab should extend just to the very edge of the idler bracket.

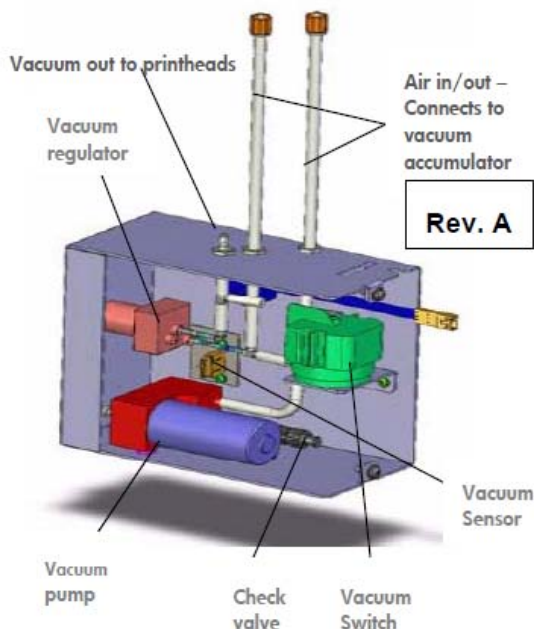
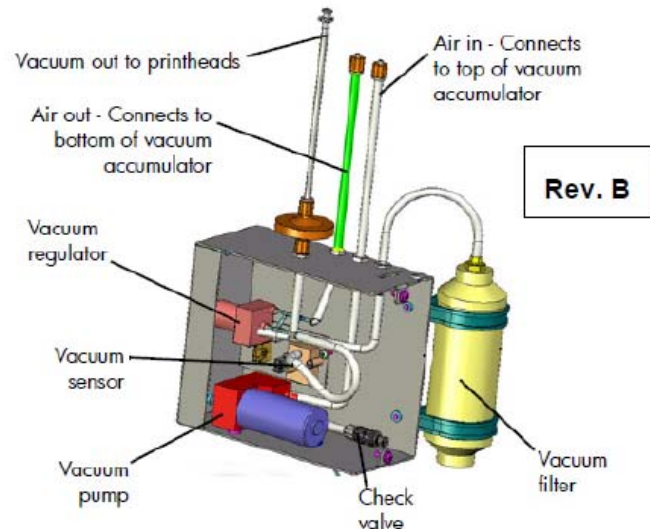
1. Verify if the vacuum assembly is the newest build or not as this error is most commonly related to the older revision vacuum assembly (Rev. A) that did not include a filter to prevent dust particles from entering the vacuum assembly.

2. If the vacuum assembly is the Rev. A version, remove the vacuum restrictor (Located in tubing attached to the back of the vacuum regulator you will find a small brass fitting). Once removed, take compressed air and blow through the small orifice to remove any dust or debris that may be located within this part. Perform a purge cycle to retest and see if the issue is resolved, if not proceed to next step.

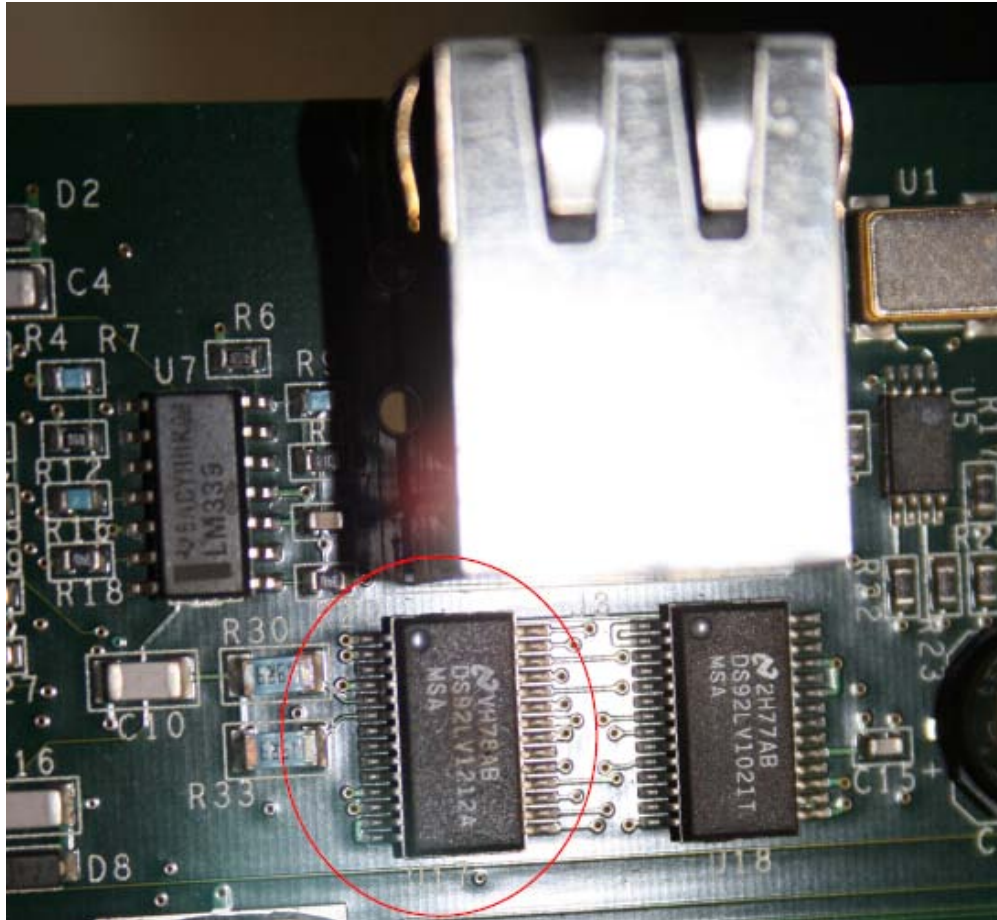
1. Find out if any of the cable connections to the headboard were reseated with the printer powered on. If this is the case, it is very likely that the headboard and/or the I/O have been damaged. The best way to determine if there is damage to the headboard or I/O board is to look directly below the data cable connector. You will see two chips directly below this, one or both of which may have a brownish tint. If these chips are bad, they will also feel very hot to the touch when the printer is powered on.

2. Power down the printer and reseal the data and power cable connections to the headboard and I/O board. Ensure the data cable does not have any strain on it that may cause the data cable connection to shift during carriage movement. The data cable should have an excess loop as it comes out of the track assembly as to allow this cable to plug in straight up and down.
