## Repair Guide Block Noise Printing VS Series

November 11, 2011

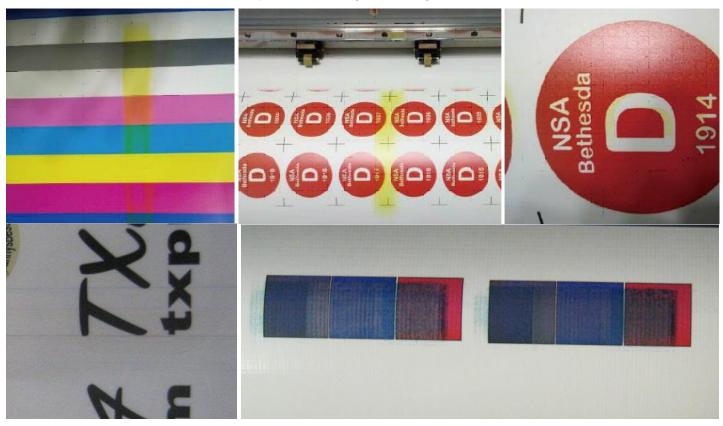
Colors printed in vertical lines or blotchy, offset printing. See images below for clarification.

The cause of the issue is a misalignment in the long data cables which send the signal to the print heads. The misalignment causes a digital noise which causes print quality issues. The misalignment has also been attributed to print and cut accuracy issues as well.

Steps to resolve the issue are contained in the following pages.

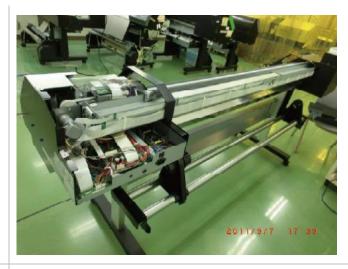
**1.** Remove all exterior covers from the printer.

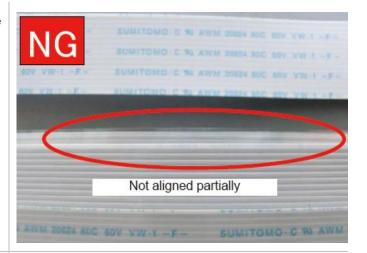
**7.** On the back side of the printer check the path of the long ribbon cables and make sure they are aligned. The tolerance is within one signal line.

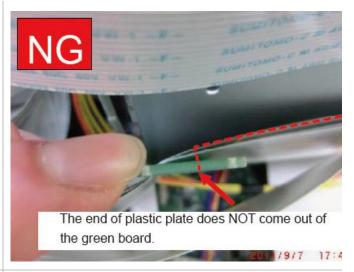
**13.** On the capping station side of the printer there is a plastic plate. Make sure the clear insulation cable passes through the green board.

**14.** If the insulation cable does not pass through the green board make the correction so it appears as it does in the image by following the next steps. If it is ok, the process is complete.
